# the **play inspection** company

## Annual Inspection

Mid Suffolk District Council

Bacton

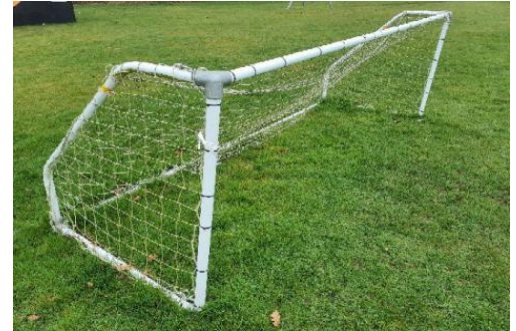
**Item:** 5 a side Goals  
**Manufacturer:** Not Identified  
**Surface Type:** Grass  
**Item Part Number:**  
**Item Quantity:** 1  
**Equipment Compliance:** N/A  
**Surface Area Compliance:** N/A  
**Total Findings:** 5

The goals are not anchored in position - Refer to manufacturer recommendations and provide as required

The surface has eroded in some areas and may be slippery in wet conditions - Reinstate the surface

Cable ties are present and there are sharp projecting ends - Replace with a more appropriate fixing method

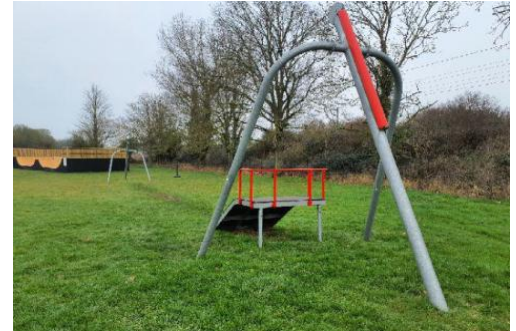
**Item:** Cable Runway  
**Manufacturer:** Sutcliffe Play Limited  
**Surface Type:** Grass Matrix Tiles  
**Item Quantity:** 1  
**Equipment Compliance:** No  
**Surface Area Compliance:** Yes

We have completed a visual inspection of the suspension links, cable and fixing points from ground level, however it is not possible to fully inspect these areas without either hiring equipment to gain access or removing the cable and suspension and inspecting at ground level. We recommend that the main cable and fixing security is thoroughly inspected at least in accordance with the manufacturers recommendations to check for wear, damage, security or internal rusting; this will help to ensure the continued safe use of the equipment - Inspect in accordance with the manufacturers recommendations

The seat connector is worn more than 40% and requires replacement - Replace seat connector if possible or replace seat

The top chain links are worn excessively and require renewing - Replace worn chains

There is or are fixings missing on the item - Replace all missing fixings

The nylon inserts are worn or missing at the point the cable enters the traveller - Replace worn or missing inserts as required

The traveller bearing is showing signs of wear - Monitor for any further deterioration and repair or replace if required

The dampening spring or tyre is damaged or broken on the item - Replace spring or tyre

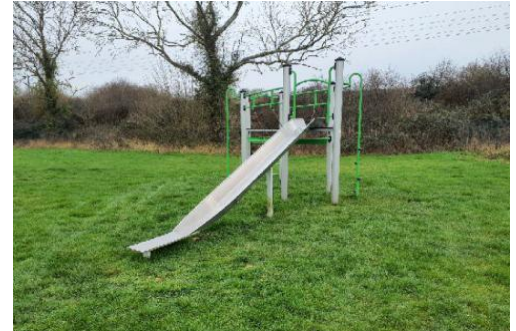
**Item:** Multi Play (Junior)  
**Manufacturer:** Sutcliffe Play Limited  
**Surface Type:** Grass Matrix Tiles  
**Item Quantity:** 1  
**Equipment Compliance:** No  
**Surface Area Compliance:** Yes

The side of the slide extends less than 500mm above the slide surface at the start section and does not meet the recommendations of BS EN 1176 Part 3 - Monitor - No action given the risk assessment

The item fails to meet the requirements of BS EN 1176 Part 1 4.2.7.2 for head and neck entrapment in the frame - Monitor - No action given the risk assessment

There are a number of dents in the slide surface - Monitor for any further deterioration and repair as required

There is some evidence of rot in the timber - Monitor for any further deterioration and replace as required

There is/are finger entrapment/s in the frame and the item fails to meet the requirements of BS EN 1176 Part 1 4.2.7.6 Entrapment of fingers - Monitor - No action given the risk assessment

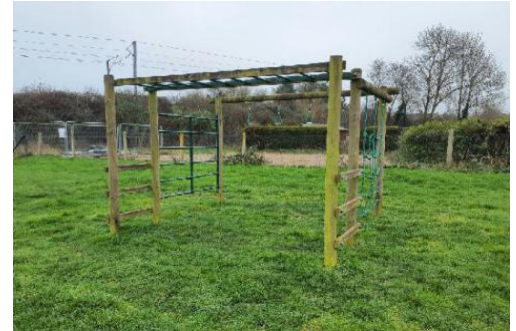
**Item:** Climbing Frame  
**Manufacturer:** Action Play and Leisure  
**Surface Type:** Grass Matrix Tiles  
**Item Quantity:** 1  
**Equipment Compliance:** Yes  
**Surface Area Compliance:** Yes

Bolt cap cover/s missing or damaged - Replace

There is some strimmer / machinery damage apparent on the posts, this can penetrate the preservative applied to the timber and accelerate the rotting process - Monitor for any deterioration (rot) and replace as required

The use of synthetic fillers in timber is not recommended; timber being a natural material will expand and contract as the moisture content changes and the use of fillers can exacerbate the length and depth of these cracks or shakes in the timber. The only treatment that is normally required is the removal of any rough or sharp edges unless the structural integrity of the item is affected. - Remove any rough or sharp edges and monitor timber for any further deterioration

There is some wear to the shackles - Monitor for any further deterioration and replace when 40% worn

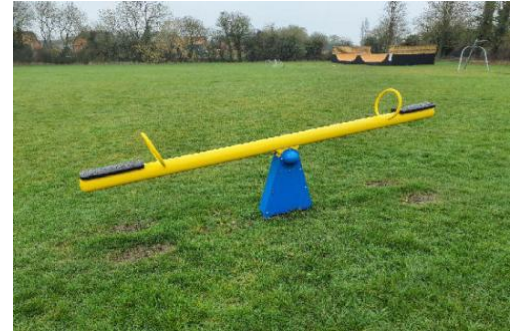
**Item:** See Saw  
**Manufacturer:** Yates Playgrounds Ltd  
**Surface Type:** Grass Matrix Tiles  
**Item Quantity:** 1  
**Equipment Compliance:** No  
**Surface Area Compliance:** Yes

The item fails to meet the requirements of BS EN 1176 Part 1 4.2.7.2 for head and neck entrapment in the frame - Monitor - No action given the risk assessment

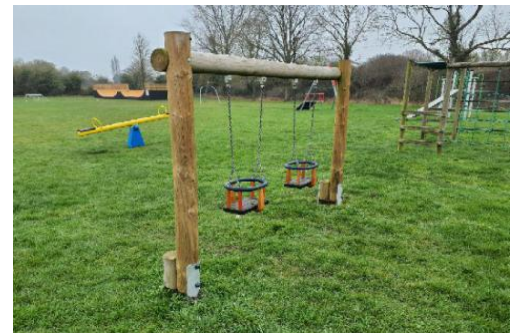
**Item:** 1 Bay 2 Seat (Cradle)  
**Manufacturer:** Action Play and Leisure  
**Surface Type:** Grass  
**Item Quantity:** 1  
**Equipment Compliance:** Yes  
**Surface Area Compliance:** Yes

This design of swing joint has been known to fail on the weld connecting the joint to the threaded stud - We would recommend that the joint be dismantled and checked on a regular basis or consulting with manufacturer on whether a Secondary Safety Device can be fitted

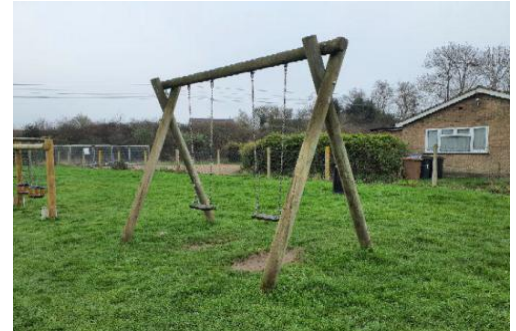
**Item:** 1 Bay 2 Seat (Flat)  
**Manufacturer:** Adventure Playgrounds  
**Surface Type:** Grass Matrix Tiles  
**Item Quantity:** 1  
**Equipment Compliance:** No  
**Surface Area Compliance:** No

There is some strimmer / machinery damage apparent on the posts, this can penetrate the preservative applied to the timber and accelerate the rotting process - Monitor for any deterioration (rot) and replace as required

There is some evidence of rot in the timber - Monitor for any further deterioration and replace as required

There is some notable evidence of chain wear - Monitor for any further deterioration and replace when 40% worn

The surfacing width under the seat/s is / are less than 875mm when measured from the centre of the seat outwards, and fail the requirements of BS EN 1176 Part 2 - Monitor - No action given the risk assessment

The bushes are worn or missing - Replace worn or missing bushes

There is some wear to the shackles - Monitor for any further deterioration and replace when 40% worn

The timber has a number of splits/shakes or air cracks and this may affect the stability or allow water ingress which will accelerate the rotting process. Timber splits may also create rough / splintering edges. - Monitor, sand down any rough edges and ensure the splits do not cross through fixing points of the structure and/or cause any instability

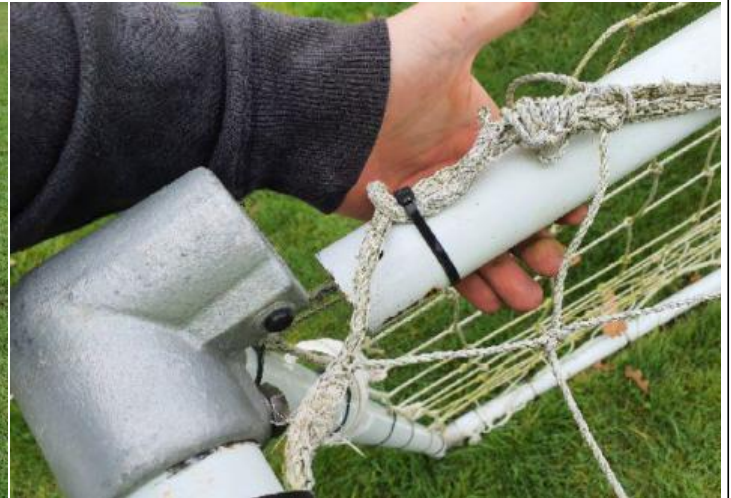
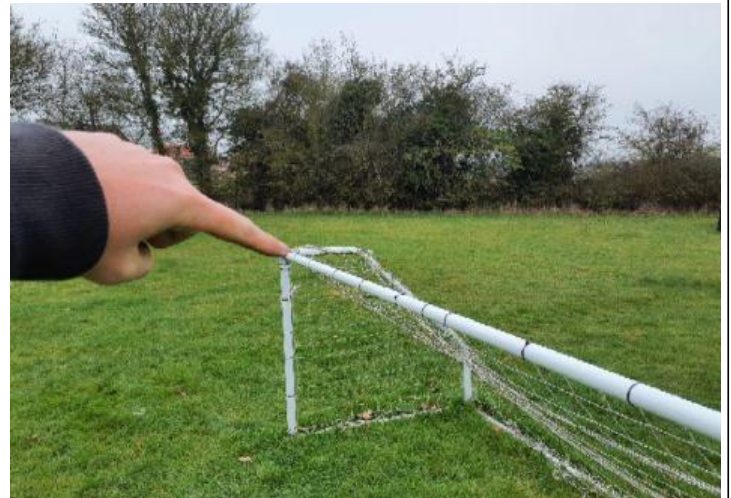
**Finding:** Parts of the framework is unsecured

**Action:** Secure

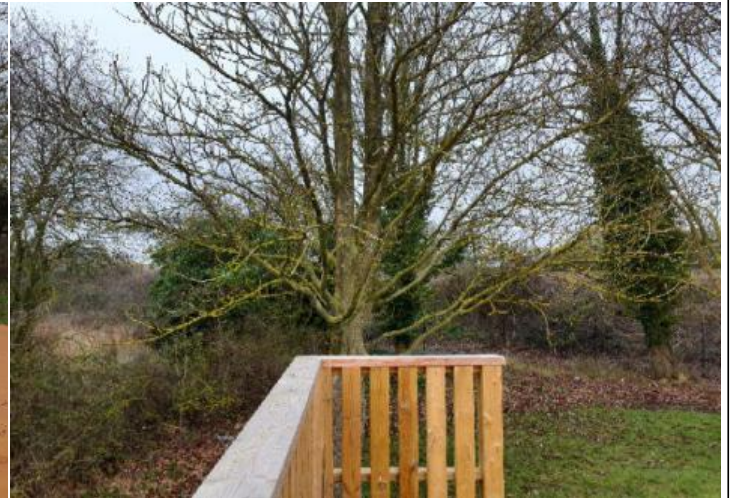
**Finding:** The tree canopy overhangs the equipment and is less than 2.0m away

**Action:** Lift tree canopy to ensure a minimum clearance of 2.0m from the equipment

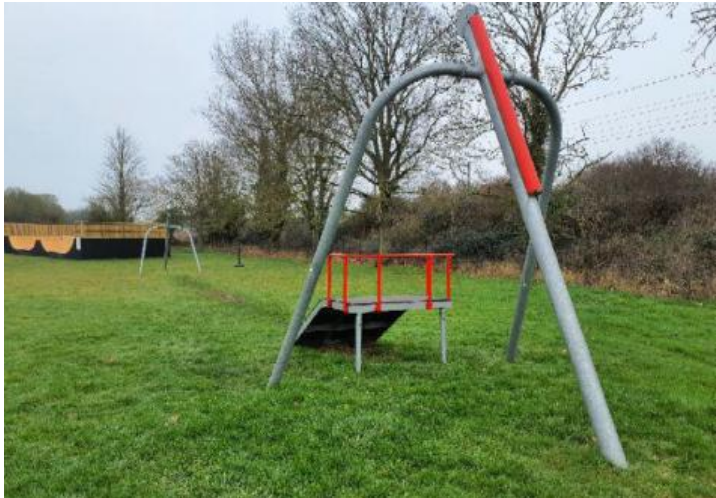
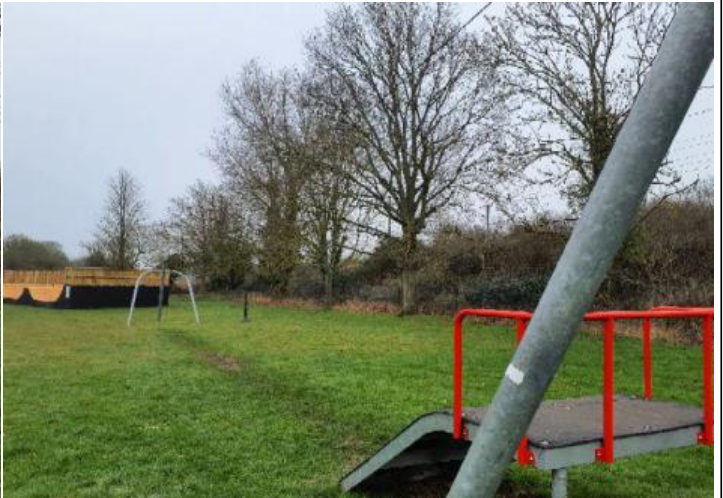
**Finding:** We have completed a visual inspection of the suspension links, cable and fixing points from ground level, however it is not possible to fully inspect these areas without either hiring equipment to gain access or removing the cable and suspension and inspecting at ground level. We recommend that the main cable and fixing security is thoroughly inspected at least in accordance with the manufacturers recommendations to check for wear, damage, security or internal rusting; this will help to ensure the continued safe use of the equipment

**Action:** Inspect in accordance with the manufacturers recommendations

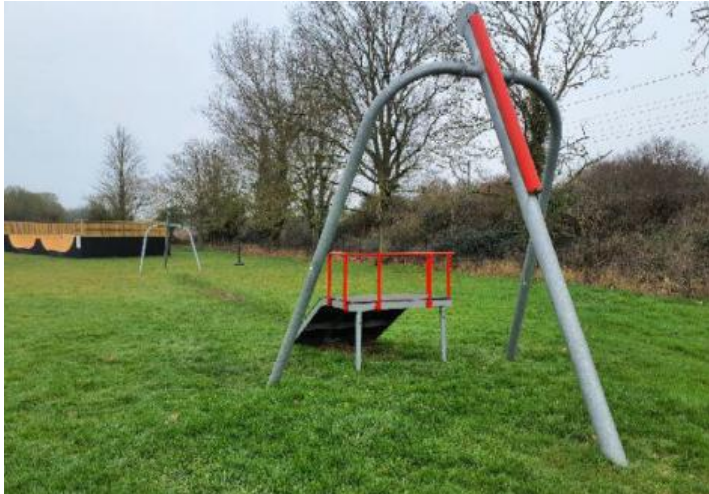
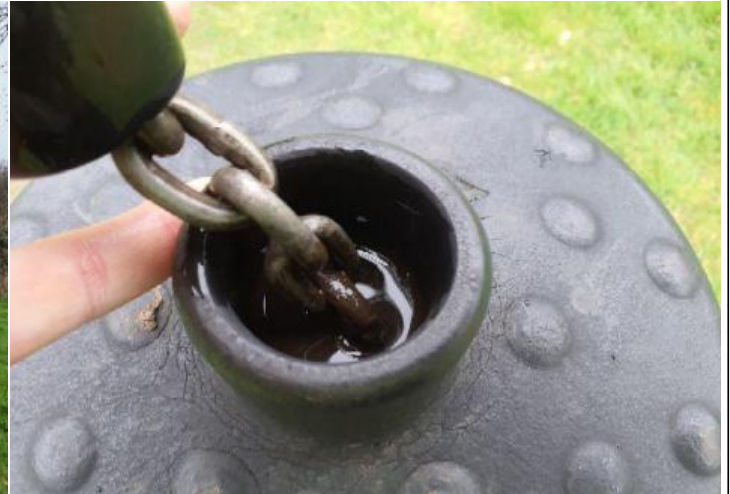
**Finding:** The seat connector is worn more than 40% and requires replacement

**Action:** Replace seat connector if possible or replace seat

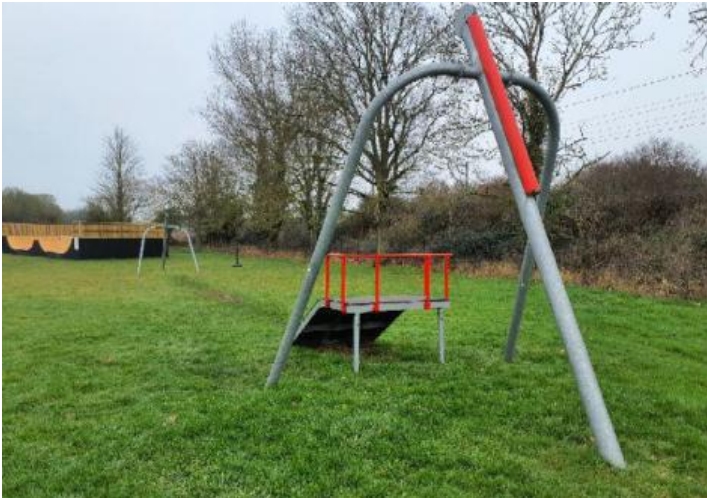
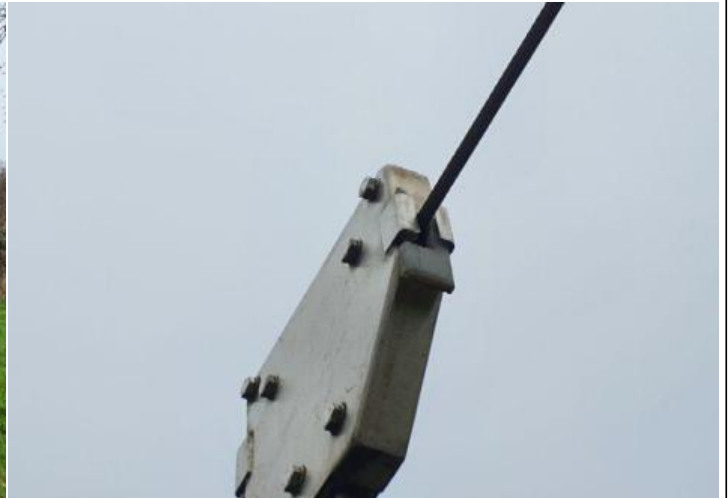
**Finding:** The nylon inserts are worn or missing at the point the cable enters the traveller

**Action:** Replace worn or missing inserts as required

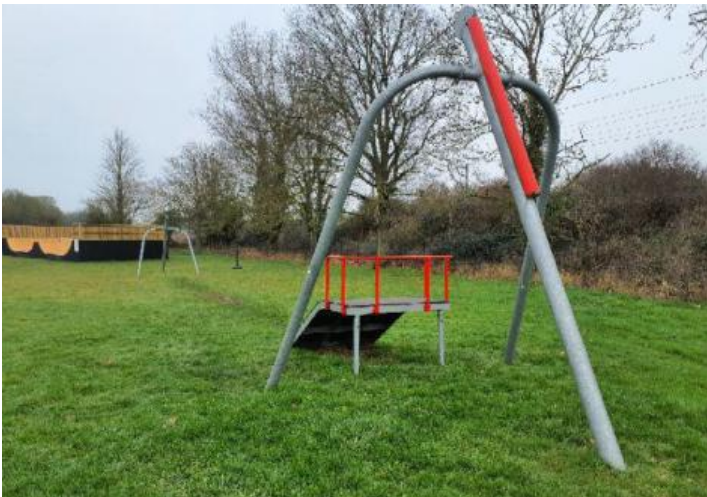
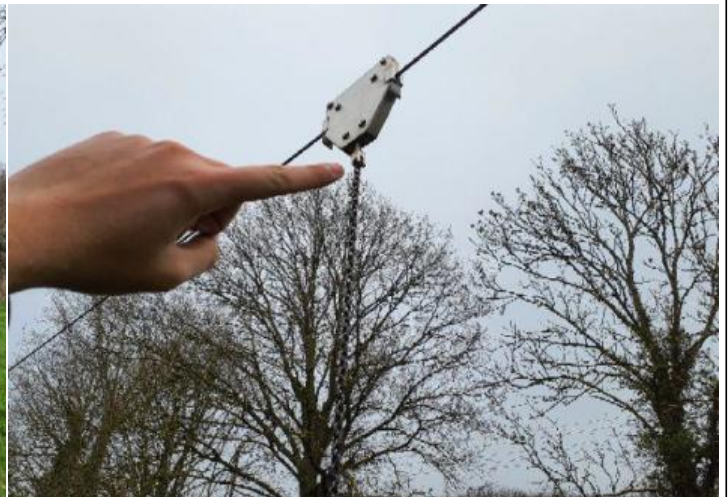
**Finding:** The top chain links are worn excessively and require renewing

**Action:** Replace worn chains

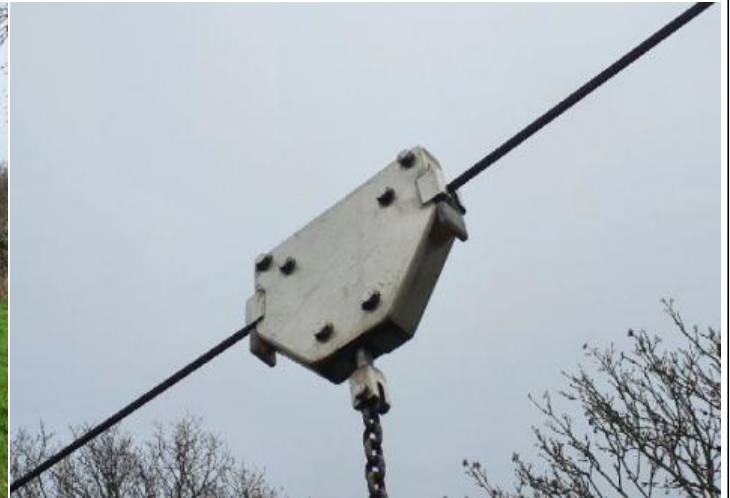
**Finding:** The traveller bearing is showing signs of wear

**Action:** Monitor for any further deterioration and repair or replace if required

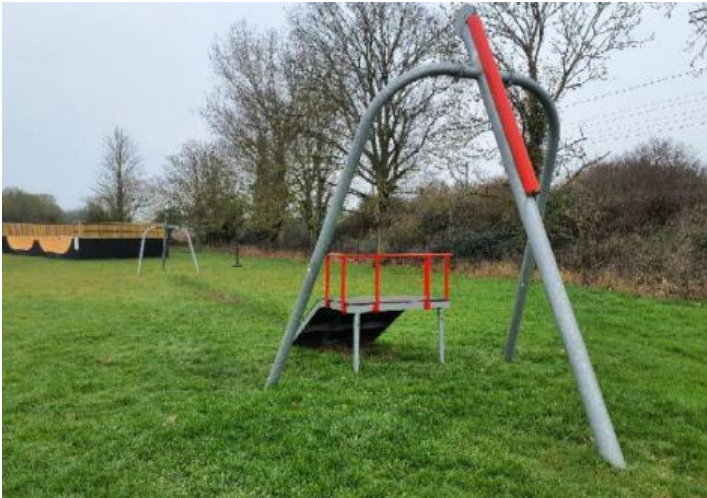
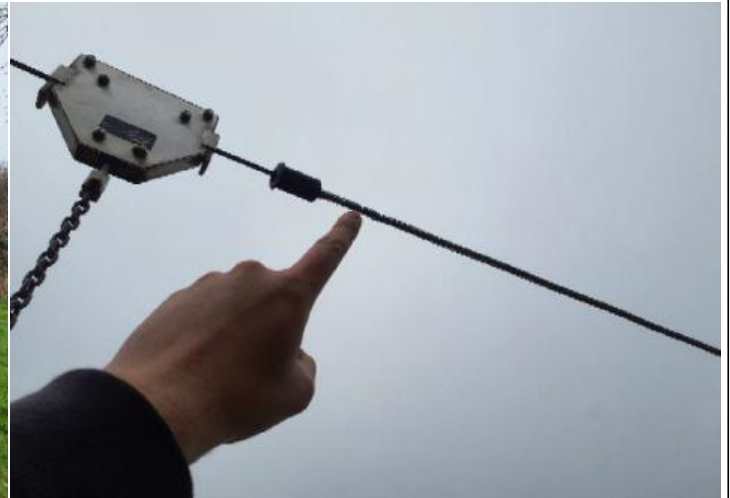
**Finding:** The dampening spring or tyre is damaged or broken on the item

**Action:** Replace spring or tyre

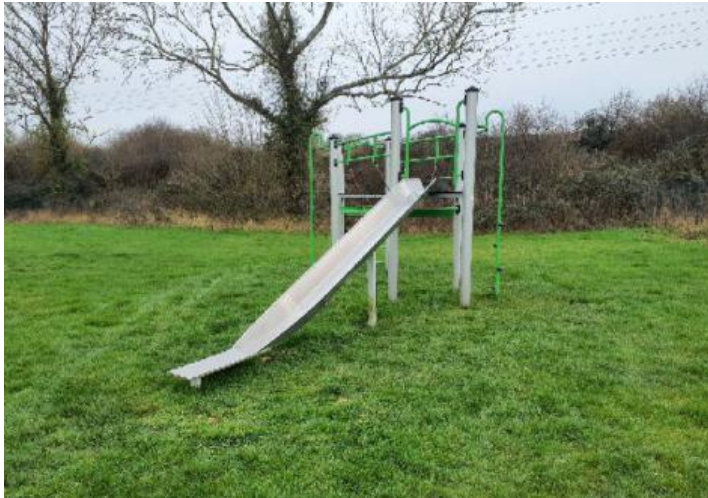
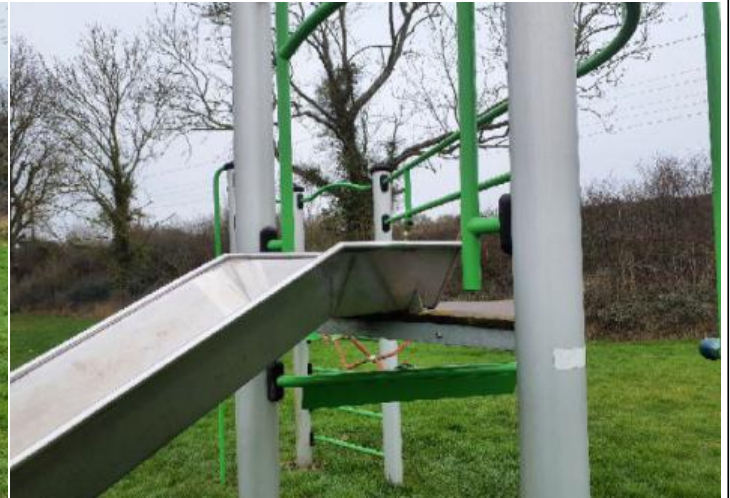
**Finding:** The side of the slide extends less than 500mm above the slide surface at the start section and does not meet the recommendations of BS EN 1176 Part 3

**Action:** Monitor - No action given the risk assessment

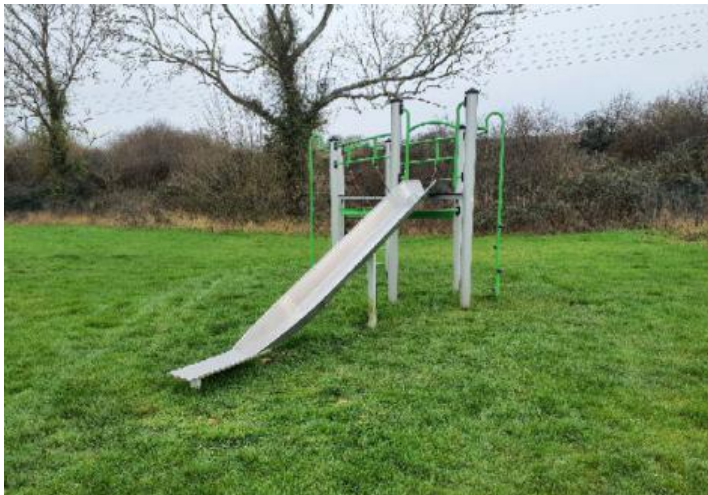
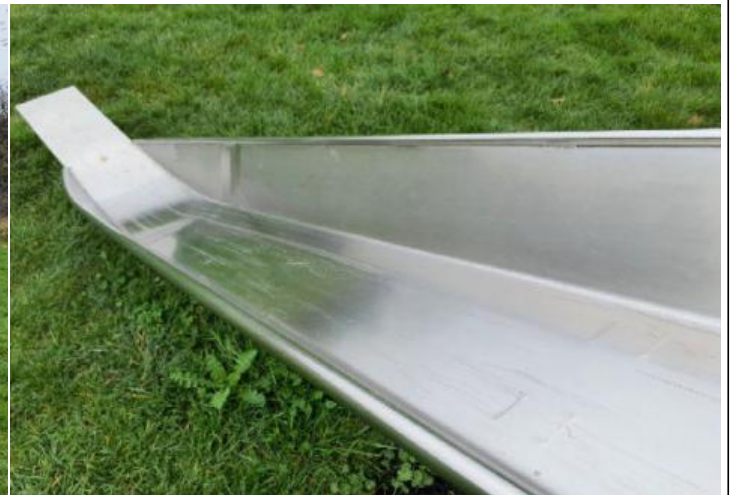
**Finding:** There are a number of dents in the slide surface

**Action:** Monitor for any further deterioration and repair as required

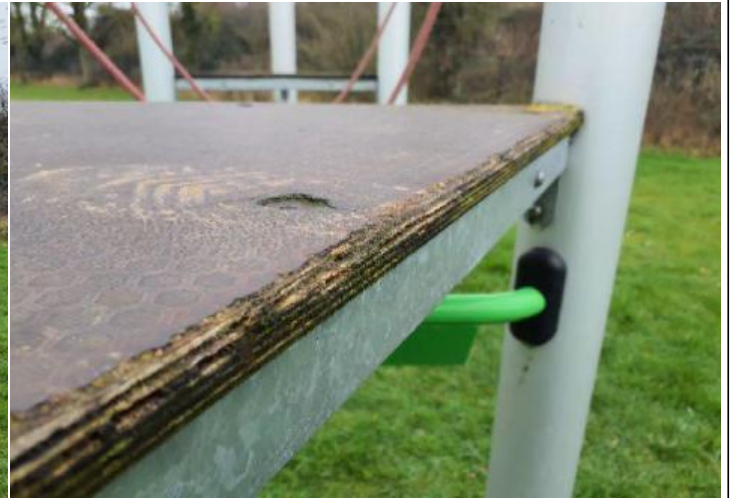
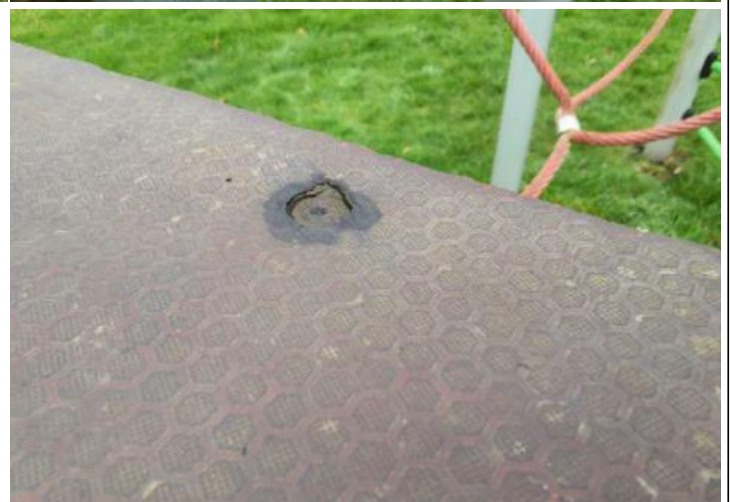
**Finding:** There is some evidence of rot in the timber

**Action:** Monitor for any further deterioration and replace as required

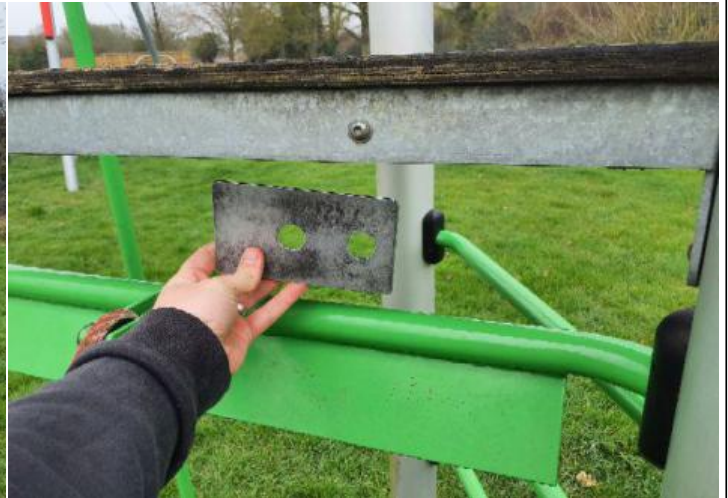
**Finding:** The item fails to meet the requirements of BS EN 1176 Part 1 4.2.7.2 for head and neck entrapment in the frame

**Action:** Monitor - No action given the risk assessment

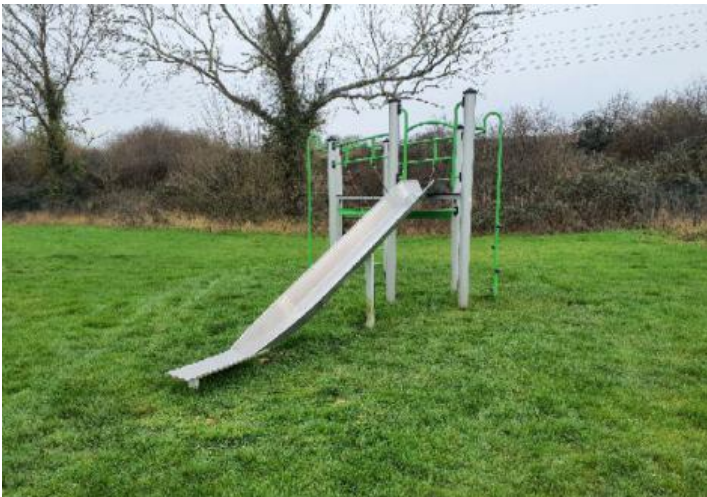
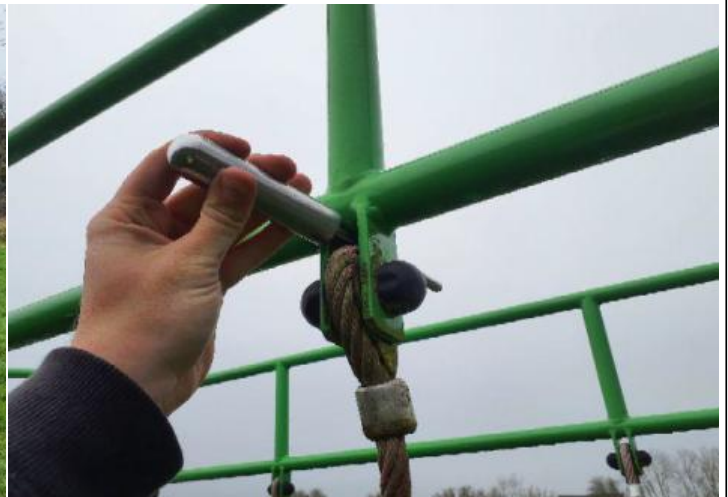
**Finding:** There is/are finger entrapment/s in the frame and the item fails to meet the requirements of BS EN 1176 Part 1 4.2.7.6 Entrapment of fingers

**Action:** Monitor - No action given the risk assessment

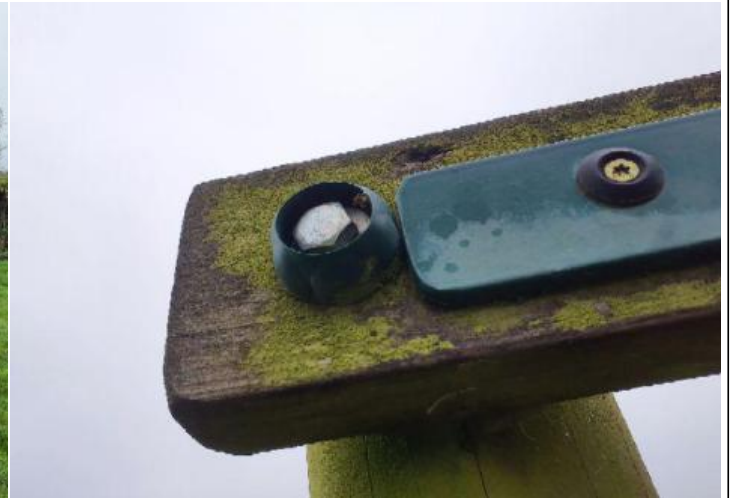
**Finding:** Bolt cap cover/s missing or damaged

**Action:** Replace

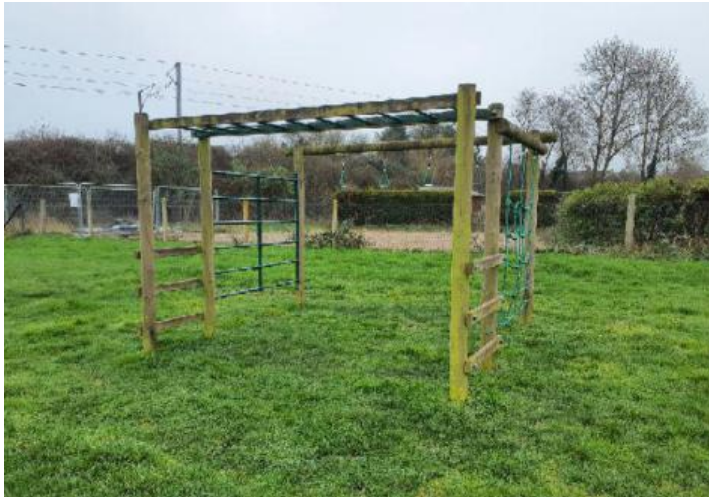
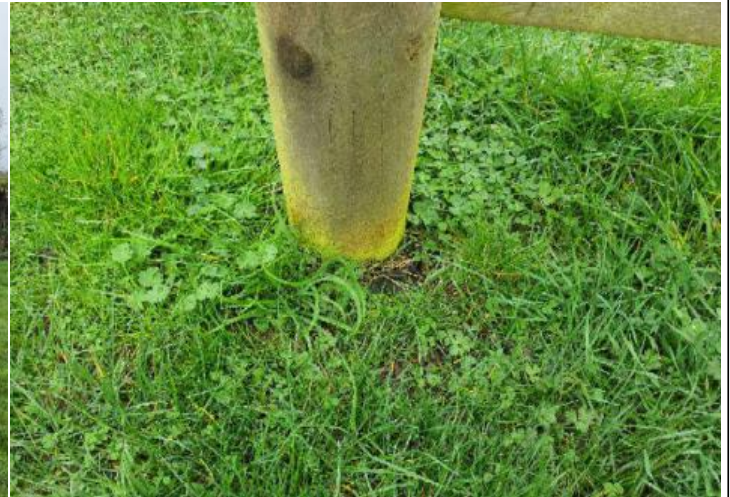
**Finding:** There is some strimmer / machinery damage apparent on the posts, this can penetrate the preservative applied to the timber and accelerate the rotting process

**Action:** Monitor for any deterioration (rot) and replace as required

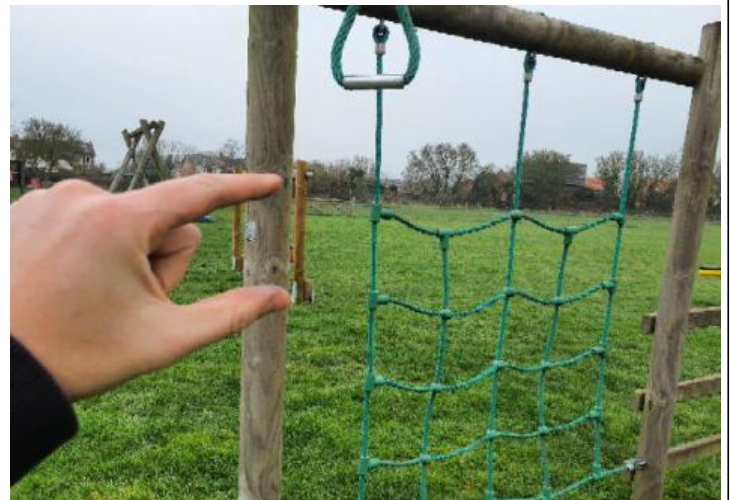
**Finding:** There are redundant screws in the post

**Action:** Remove

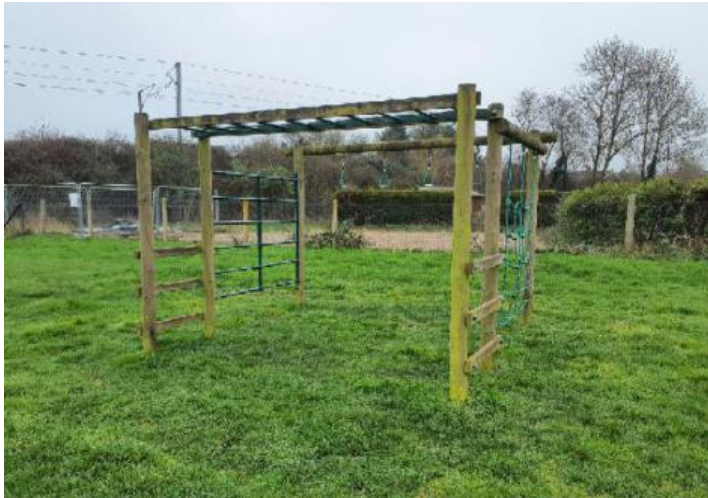
**Finding:** The use of synthetic fillers in timber is not recommended; timber being a natural material will expand and contract as the moisture content changes and the use of fillers can exacerbate the length and depth of these cracks or shakes in the timber. The only treatment that is normally required is the removal of any rough or sharp edges unless the structural integrity of the item is affected.

**Action:** Remove any rough or sharp edges and monitor timber for any further deterioration

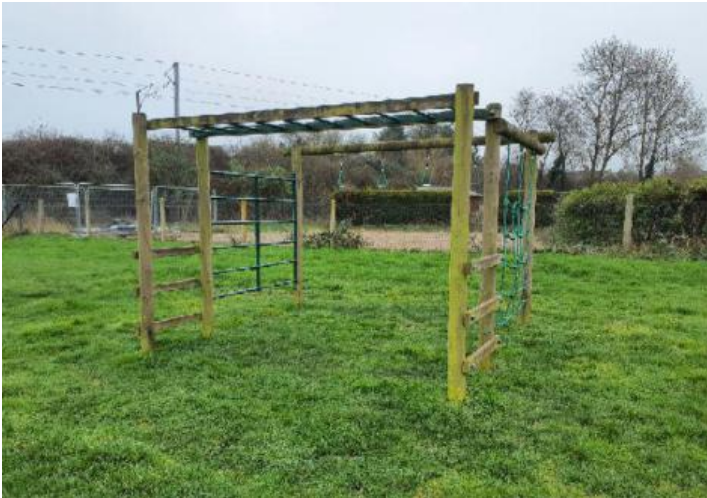
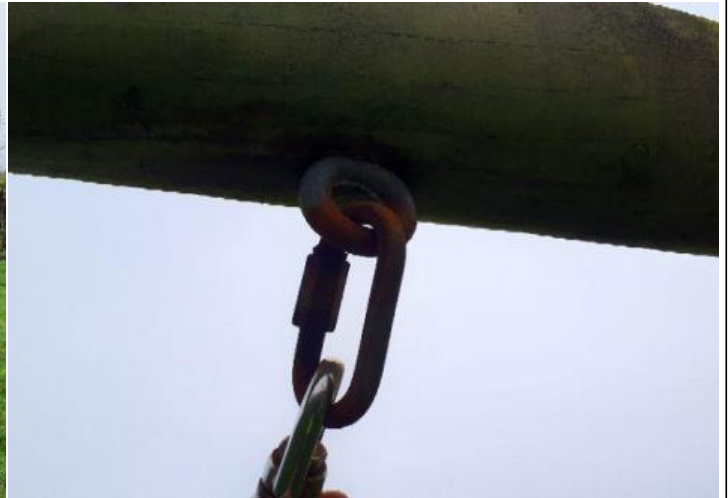
**Finding:** There is some wear to the shackles

**Action:** Monitor for any further deterioration and replace when 40% worn

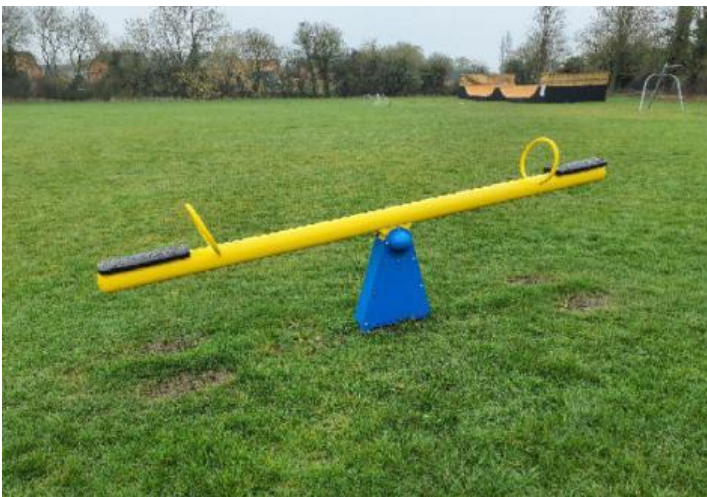
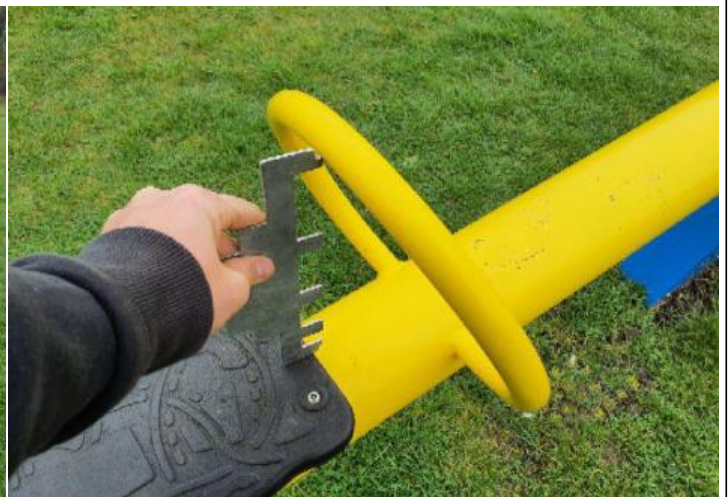
**Finding:** The item fails to meet the requirements of BS EN 1176 Part 1 4.2.7.2 for head and neck entrapment in the frame

**Action:** Monitor - No action given the risk assessment

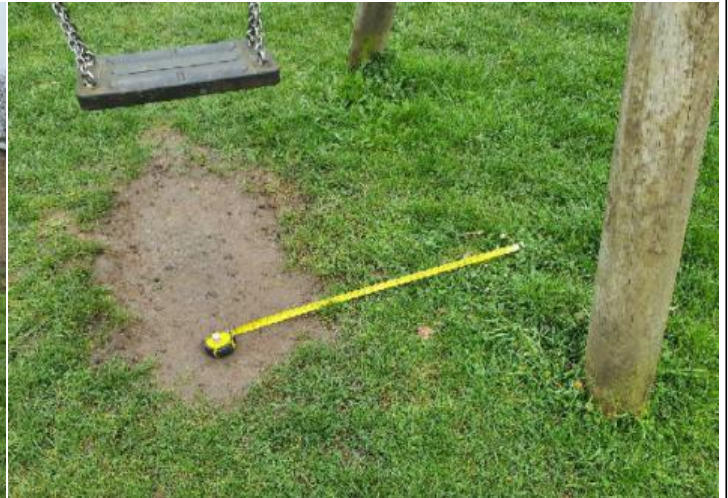
**Finding:** The surfacing width under the seat/s is / are less than 875mm when measured from the centre of the seat outwards, and fail the requirements of BS EN 1176 Part 2

**Action:** Monitor - No action given the risk assessment

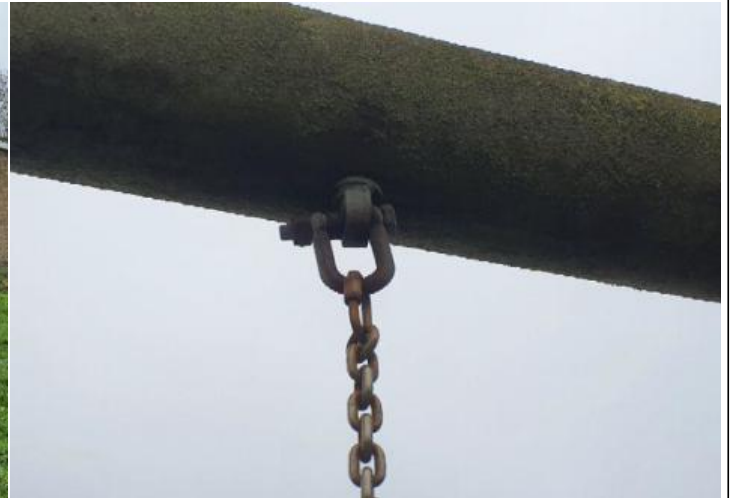
**Finding:** There is some wear to the shackles

**Action:** Monitor for any further deterioration and replace when 40% worn

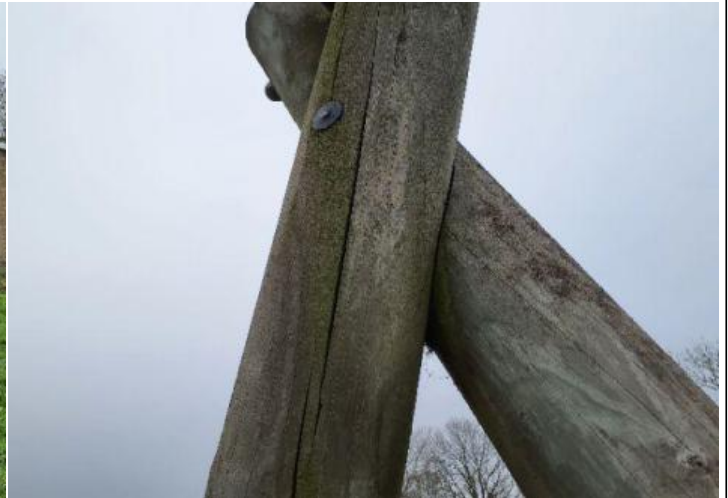
**Finding:** The timber has a number of splits/shakes or air cracks and this may affect the stability or allow water ingress which will accelerate the rotting process. Timber splits may also create rough / splintering edges.

**Action:** Monitor, sand down any rough edges and ensure the splits do not cross through fixing points of the structure and/or cause any instability
