# the **play inspection** company

## Annual Inspection

Mid Suffolk District Council

Bacton

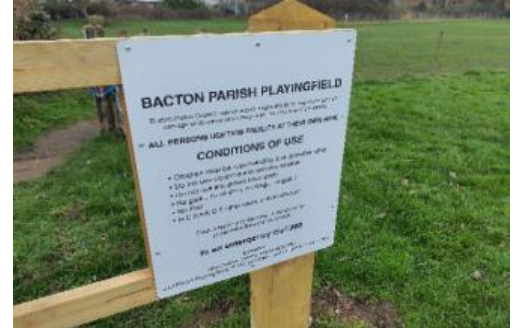
**Item:** Sign  
**Manufacturer:** Not Identified  
**Surface Type:** N/A  
**Item Quantity:** 1  
**Equipment Compliance:** N/A  
**Surface Area Compliance:** N/A

This item is satisfactory - no work required -

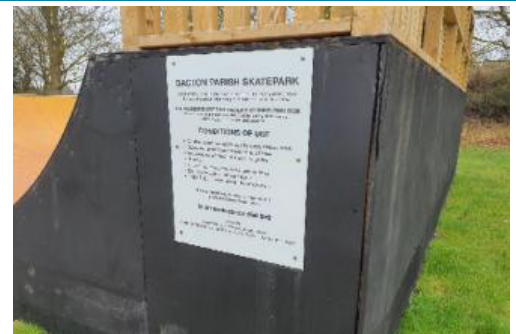
**Item:** Sign  
**Manufacturer:** Not Identified  
**Surface Type:** N/A  
**Item Quantity:** 1  
**Equipment Compliance:** N/A  
**Surface Area Compliance:** N/A

This item is satisfactory - no work required -

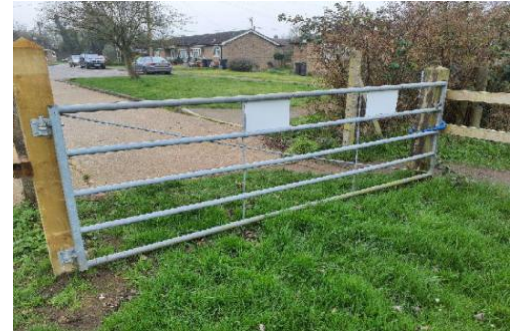
**Item:** Gate - Maintenance  
**Manufacturer:** Not Identified  
**Surface Type:** Grass  
**Item Quantity:** 1  
**Equipment Compliance:** N/A  
**Surface Area Compliance:** N/A

The maintenance gate was correctly padlocked at the time of inspection, however this means that the inspector was unable to fully assess the gate - Ensure that there are 12mm gaps throughout the full range of motion on gate/s and between leaves where relevant

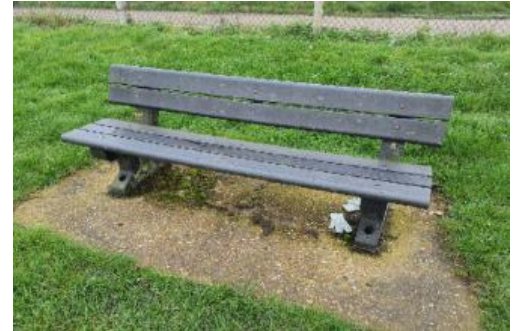
**Item:** Bench  
**Manufacturer:** Not Identified  
**Surface Type:** Concrete  
**Item Quantity:** 1  
**Equipment Compliance:** N/A  
**Surface Area Compliance:** N/A

This item is satisfactory - no work required -

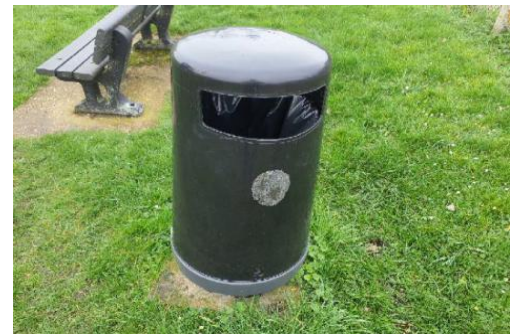
**Item:** Litter Bin  
**Manufacturer:** Not Identified  
**Surface Type:** Concrete  
**Item Quantity:** 2  
**Equipment Compliance:** N/A  
**Surface Area Compliance:** N/A

The lid or door of the litter bin is not secured - Ensure the lid or door is kept locked

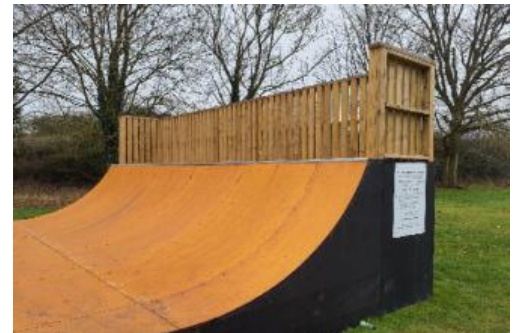
**Item:** Quarter Pipe  
**Manufacturer:** Not Identified  
**Surface Type:** Grass  
**Item Quantity:** 1  
**Equipment Compliance:** Yes  
**Surface Area Compliance:** Yes

This item is satisfactory - no work required -

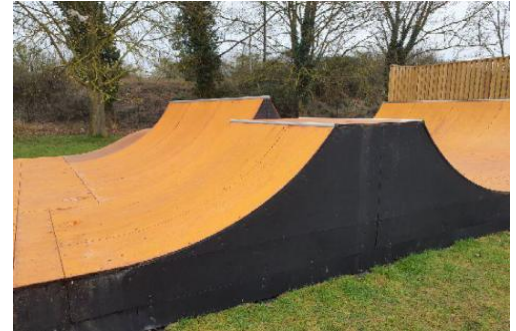
**Item:** Multi Ramp  
**Manufacturer:** Not Identified  
**Surface Type:** Grass  
**Item Quantity:** 1  
**Equipment Compliance:** No  
**Surface Area Compliance:** Yes

Joints between the riding / rolling surfaces shall not be greater than 5mm in contravention of the requirements of BS EN 14974 – 6.2.4 - Take corrective action to ensure that the gaps between the joints do not exceed 5mm

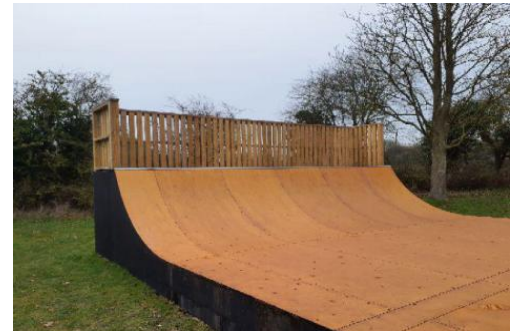
**Item:** Quarter Pipe  
**Manufacturer:** Not Identified  
**Surface Type:** Grass  
**Item Quantity:** 1  
**Equipment Compliance:** Yes  
**Surface Area Compliance:** Yes

The tree canopy overhangs the equipment and is less than 2.0m away - Lift tree canopy to ensure a minimum clearance of 2.0m from the equipment

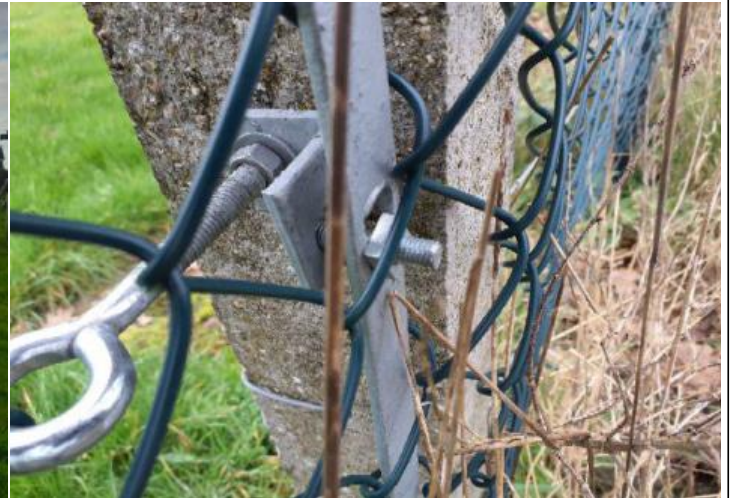
**Item:** Fences - Fence - Chainlink  
**Manufacturer:** Not Identified

**Risk Level:** L - Low Risk  
**Surface:** Grass

**Finding:** There are projecting bolt thread(s) present

**Action:** Remove excess thread length and deburr or provide cap

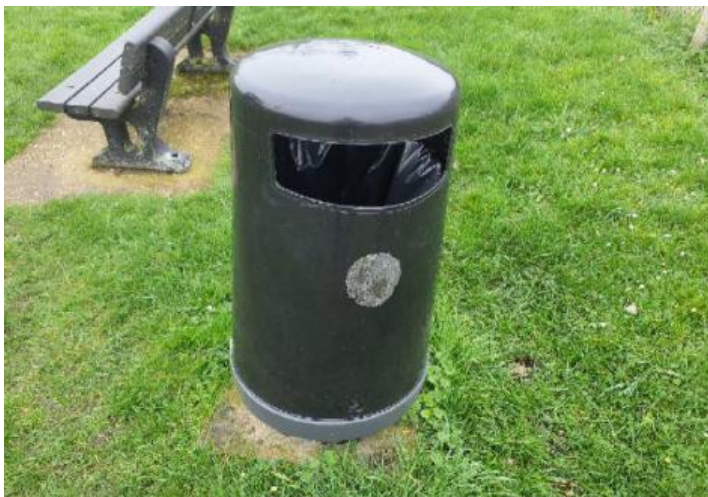
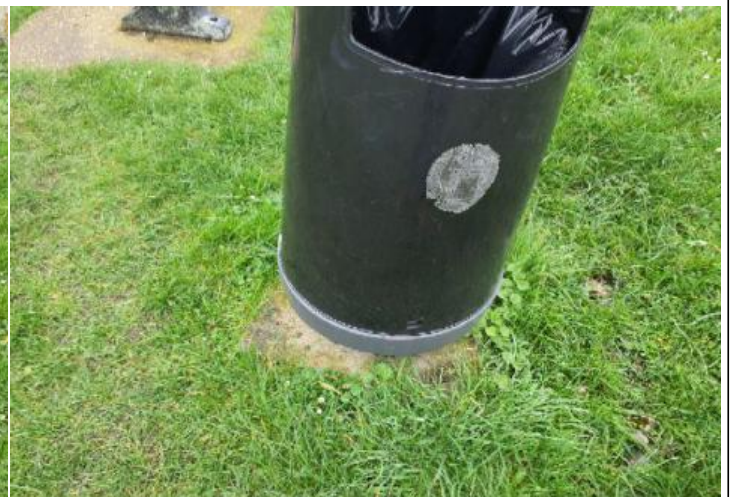
**Item:** Ancillary Items - Litter Bin  
**Manufacturer:** Not Identified

**Risk Level:** L - Low Risk  
**Surface:** Concrete

**Finding:** The lid or door of the litter bin is not secured

**Action:** Ensure the lid or door is kept locked

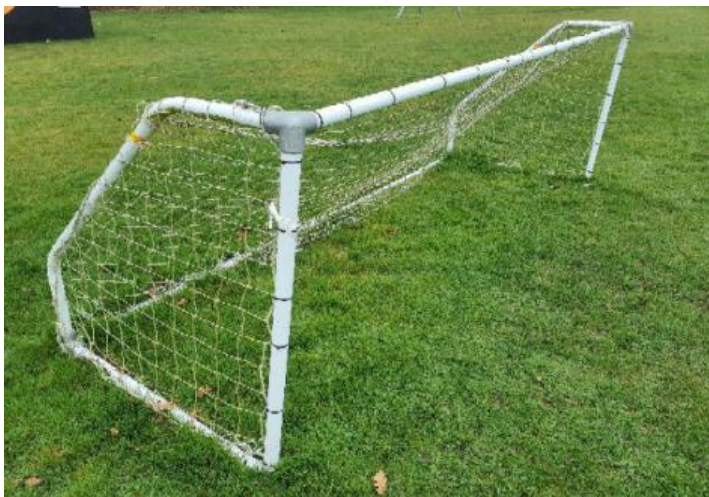
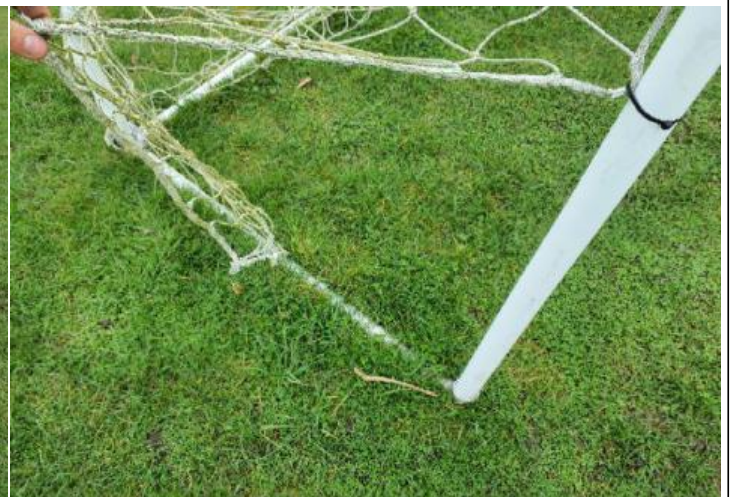
**Item:** Multi Use Games Area - 5 a side Goals  
**Manufacturer:** Not Identified

**Risk Level:** L - Low Risk  
**Surface:** Grass

**Finding:** The nets are not fully secured

**Action:** Secure nets

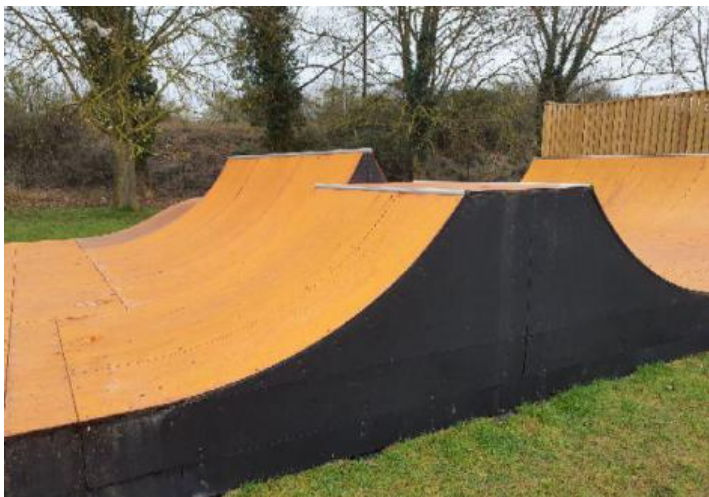
**Item:** Wheeled Sports - Multi Ramp  
**Manufacturer:** Not Identified

**Risk Level:** L - Low Risk  
**Surface:** Grass

**Finding:** Joints between the riding / rolling surfaces shall not be greater than 5mm in contravention of the requirements of BS EN 14974 – 6.2.4

**Action:** Take corrective action to ensure that the gaps between the joints do not exceed 5mm

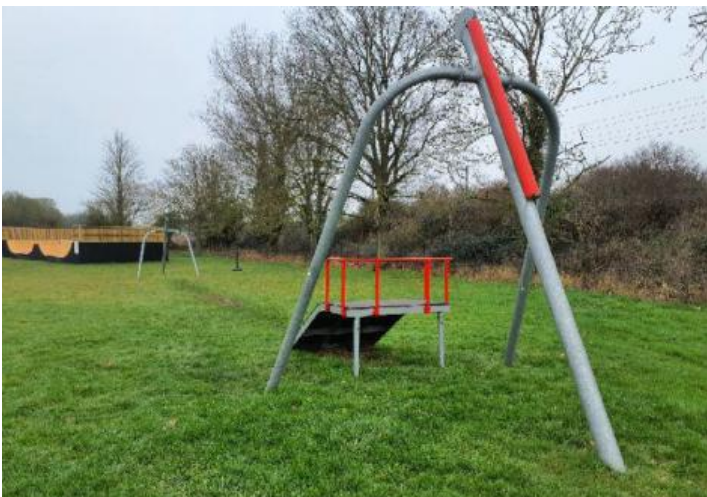
**Item:** Other - Cable Runway  
**Manufacturer:** Sutcliffe Play Limited

**Risk Level:** L - Low Risk  
**Surface:** Grass Matrix Tiles

**Finding:** The seat is less than 2.0 metres from the post when extended at 45 degrees at the end of the area of travel and does not meet the requirements of BS EN 1176 Part 4

**Action:** Adjust the cable stop position to ensure the minimum distance is maintained

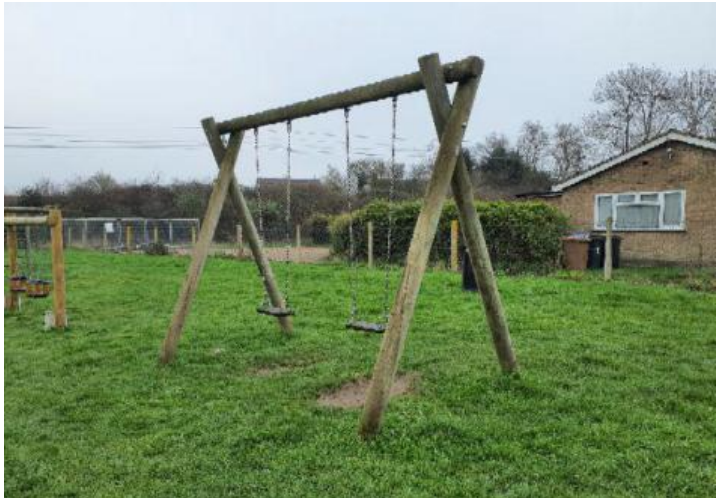
**Item:** Swings - 1 Bay 2 Seat (Flat)  
**Manufacturer:** Adventure Playgrounds

**Risk Level:** L - Low Risk  
**Surface:** Grass Matrix Tiles

**Finding:** The grass mats are silted up, the soil is compacted and the area will become very slippery when the soil is wet. **Action:** Reinststate as required

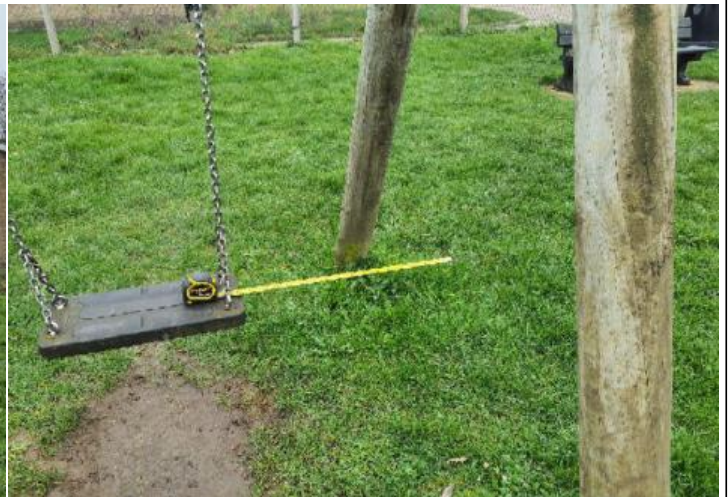
**Item:** Swings - 1 Bay 2 Seat (Flat)  
**Manufacturer:** Adventure Playgrounds

**Risk Level:** L - Low Risk  
**Surface:** Grass Matrix Tiles

**Finding:** The seat/s is / are too close to the frame as defined in BS EN 1176 Part 2

**Action:** Monitor - No action given the risk assessment

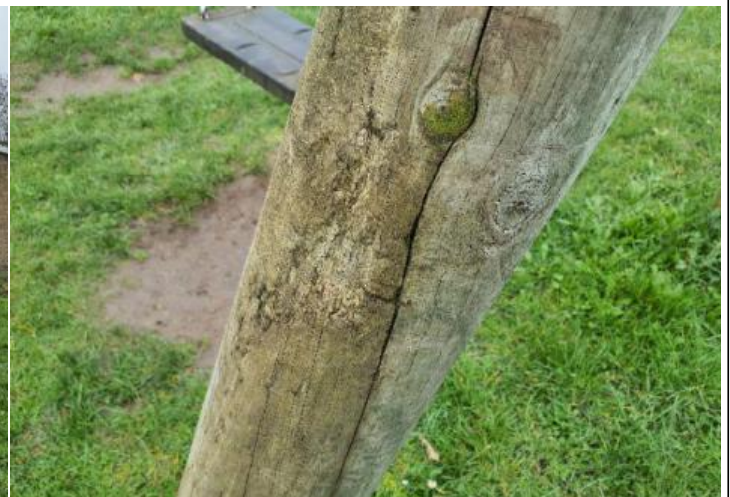
**Item:** Swings - 1 Bay 2 Seat (Flat)  
**Manufacturer:** Adventure Playgrounds

**Risk Level:** L - Low Risk  
**Surface:** Grass Matrix Tiles

**Finding:** Parts of the timber are rough or splintered

**Action:** Remove all rough or sharp edges

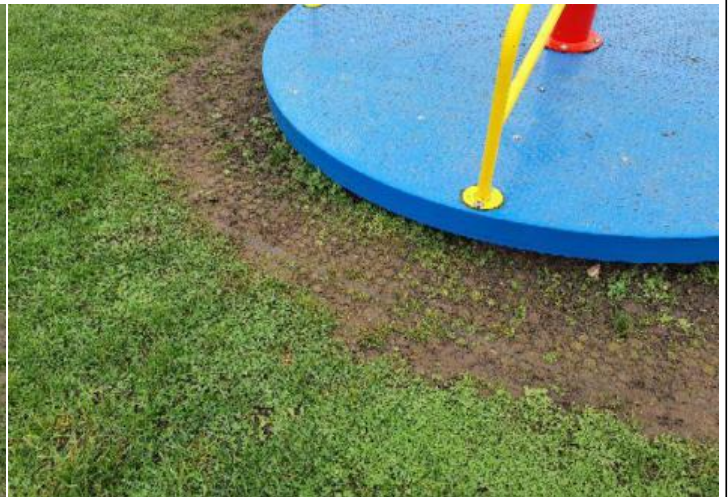
**Item:** Rotor Play - Roundabout  
**Manufacturer:** Yates Playgrounds Ltd

**Risk Level:** L - Low Risk  
**Surface:** Grass Matrix Tiles

**Finding:** The grass mats are silted up, the soil is compacted and the area will become very slippery when the soil is wet.

**Action:** Reinstate as required

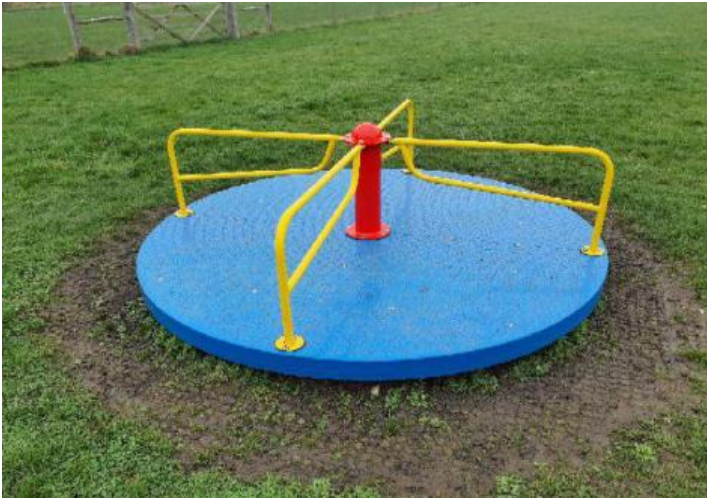
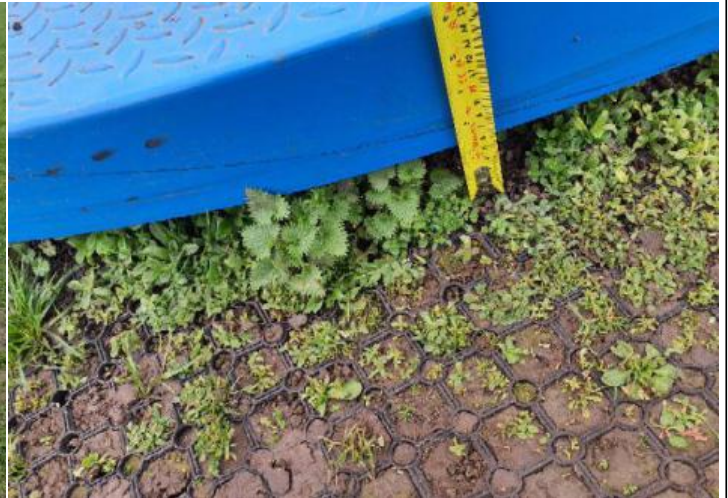
**Item:** Rotor Play - Roundabout  
**Manufacturer:** Yates Playgrounds Ltd

**Risk Level:** L - Low Risk  
**Surface:** Grass Matrix Tiles

**Finding:** The distance between the underside of the roundabout platform and the playing surface is less than 60mm and contravenes the requirements of BS EN 1176 Part 5 which requires that the distance be maintained between 60mm-110mm for the entire circumference of the roundabout

**Action:** Monitor - No action given the risk assessment

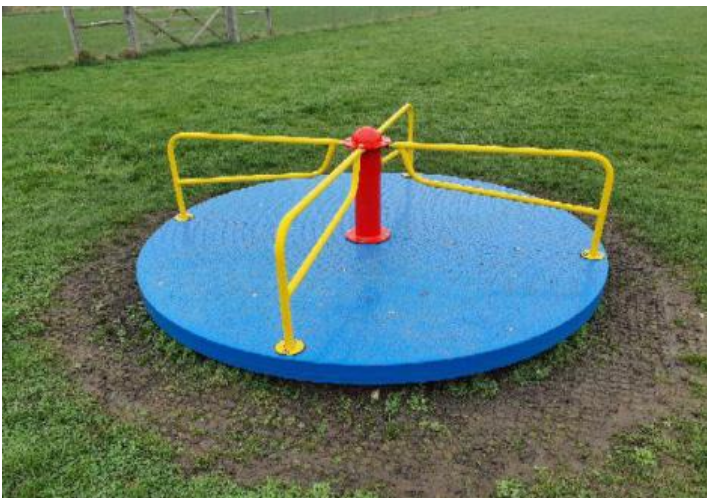
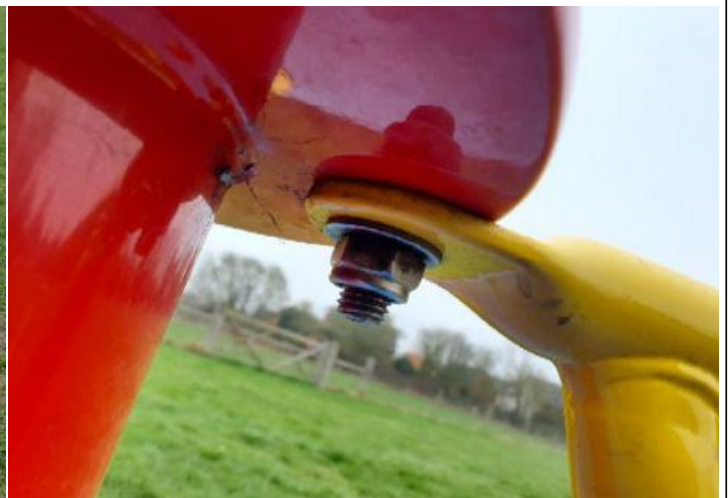
**Item:** Rotor Play - Roundabout  
**Manufacturer:** Yates Playgrounds Ltd

**Risk Level:** L - Low Risk  
**Surface:** Grass Matrix Tiles

**Finding:** There are projecting bolt thread(s) present

**Action:** Remove excess thread length and deburr or provide cap
